**TEN-YEAR RELIABILITY ASSESSMENT OF PHOTOVOLTAIC WATER
PUMPING SYSTEMS IN MEXICO**

ABSTRACT

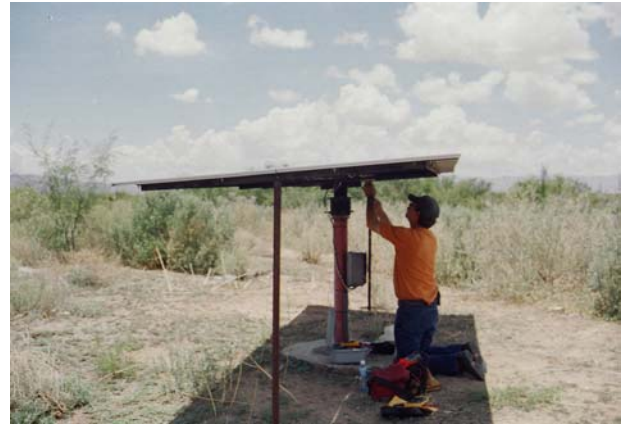
Fig. 1: FIRCO engineer conducting performance evaluation of an 8-year old PV water pumping system at Rancho Jeromín, Chihuahua.

junction boxes, breakers, and water pipe were also inspected. Technical field inspections were carried out by engineers from FIRCO, NMSU, and EcoTursimo y Nuevas Tecnologías as shown in Fig. 1.

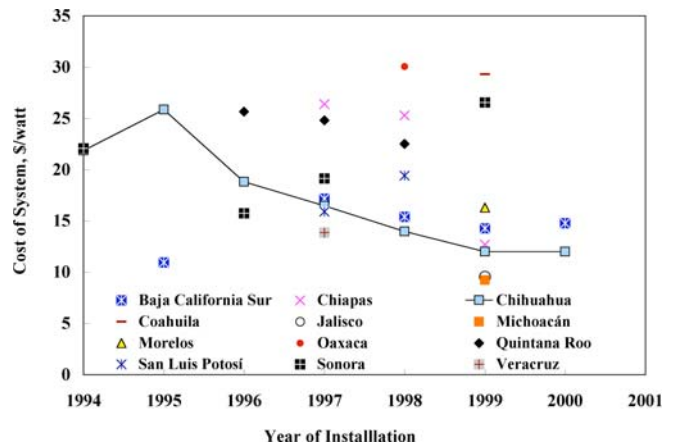
Fig. 2: Average cost of systems by year and by state.

Fig. 2 presents the average cost in dollars per watt of the PV water pumping pilot systems by state and installation year of MREP systems. The continuous line corresponds to the average cost for the installed systems in the State of Chihuahua. During the introduction of PV technology for water pumping, the cost was 22 and 25 dollars per installed watt in 1994 and 1995, respectively. After 1995, a decrease in cost reflecting PV market maturity was observed. By the end of 1999, the average cost was US\$12/Wp. Over 40 systems were installed in Chihuahua. Similar results were also seen in Baja California Sur with 40 installations. In other states, the program implemented only a few projects and the PV market had not sufficiently matured and there was less vendor competition. MREP experience shows that key factors for achieving a mature market include training, program size, multiple vendors, quality workmanship, code compliance, and technologies deployed.

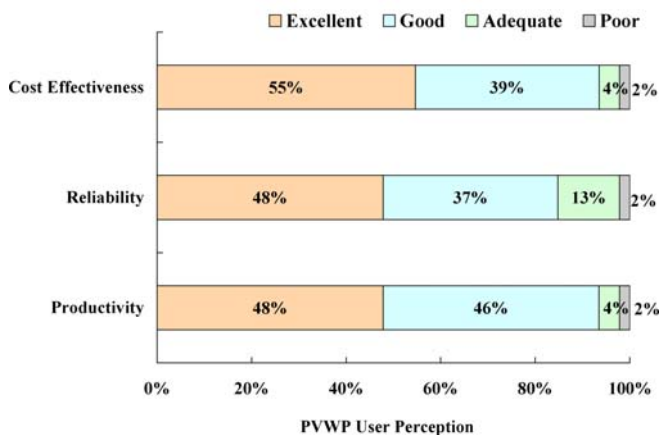
Fig. 3: User perception about cost effectiveness, reliability, and productivity of PV water pumping systems.

Fig. 3 presents the results obtained from the questions in section (2). The first bar shows that 55 percent of users agreed that the PV water pumping systems were very economical, 39 percent thought economical, 4 percent answered that they were adequate, and only 2 percent did not believe that PV systems were economically viable. Fully 48 percent of users thought that PV systems had excellent reliability, while 37 percent classified the systems with good reliability. Thirteen percent indicated that the systems had adequate reliability, while 2 percent did not classify the systems as reliable. Interestingly, some people responded this way even despite the fact their PV systems were actually not functioning at the time of the survey. For instance, in Rancho San Miguel in Baja California Sur, the ranchers blamed the system failure on the pump that failed after 7 years of operation and were satisfied that the solar system is reliable. In a number of cases, the ejido (farmers on communal ranch lands) mindset is that the Mexican government should replace any failed pumps, etc., and often are not willing to take on this responsibility themselves. The ranchers in San Miguel have gone back to using diesel pumps and are now awaiting government support, even though if the four families contributing US\$400 each can buy the required replacement PV pump and eventually save the funds now spent on diesel fuel in only a year or so.

Regarding water production, 48 percent of users classified water production as excellent, 46 percent thought the water production was good, 4 percent felt that the amount of water pumped was adequate, and 2 percent were not satisfied with the water production.

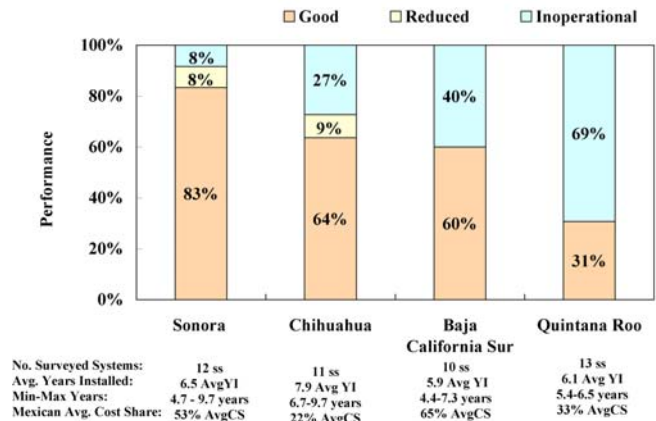
Fig. 5: Performance of surveyed systems by state.

Of the systems surveyed in Baja California Sur (10), Chihuahua (11), Quintana Roo (13) and Sonora (12), 25 of the systems were operating as designed (eight with maintenance actions previously taken), three were operating at reduced water production, and 18 were not operating, two of which had been dismantled. Fig. 5 shows the performance of the surveyed systems by state. This plot indicates that Sonora achieved the highest success rate (84%), followed by Chihuahua (64%), Baja California Sur (60%), and finally Quintana Roo (31%). In Sonora and Chihuahua results found that 8 and 9 percent of the surveyed systems were operating at reduced water production capacity (caused when submersible centrifugal pump stages have filled up with silt, which is easy to correct). Regarding the non-functioning projects, the breakdown was Sonora (8%), Chihuahua (27%), Baja California Sur (40%), and Quintana Roo (69%) with the most failures. Since water pumping is not as critical in Quintana Roo as in the northern desert states, system repair is not viewed as critical to the survival of livestock. Most of the water pumping
