## Field Testing of CdTe PV Modules in Mexico

Robert E. Foster  
Luis M. Gómez Rocha  
SWTDI - College of Engineering  
New Mexico State University.  
MSC 3SOL, P.O. Box 30001  
Las Cruces NM 88003-0001  
[rfoster@nmsu.edu](mailto:rfoster@nmsu.edu)

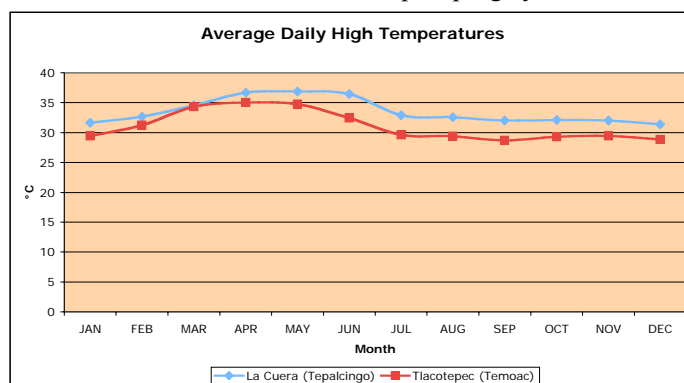
Fig. 1. Average monthly daily high temperatures near First Solar test sites in Morelos, Mexico [1].

In Morelos, climate varies with altitude, from relatively cool pine forests in the mountains, to hot and humid plains at lower elevations. The predominant climate zone throughout the state of Morelos is hot and humid, centered in the lower elevations of the Amacuzac and Nexapa river basins. The zone is dominant in the central and southern parts of the state, bordering both the States of Mexico and Guerrero. PV systems were tested in the hot and humid climate zone of Morelos as defined by INEGI. This climate zone has an annual average temperature above 22°C, with daytime highs between 30-37°C. The hot climate zones get the most rainfall during the summer, and less in the winter. [1]

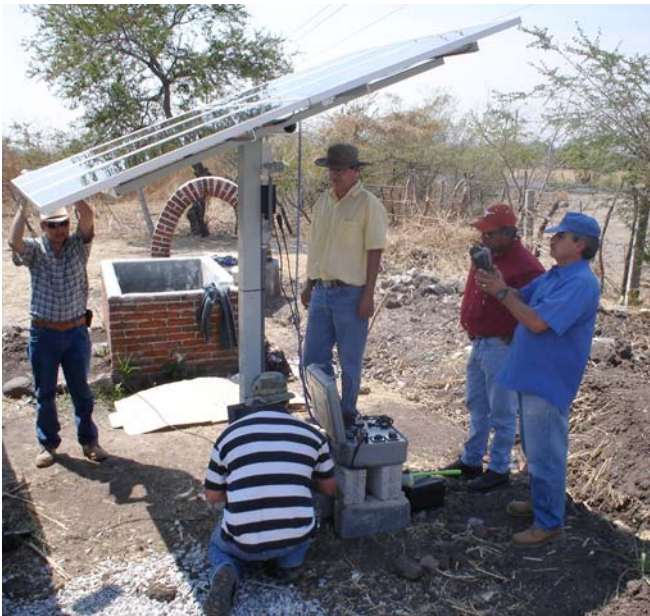
Fig. 2. Huitchila PV Array in Las Margaritas under test by UNAM, NMSU, and FIRCO personnel.

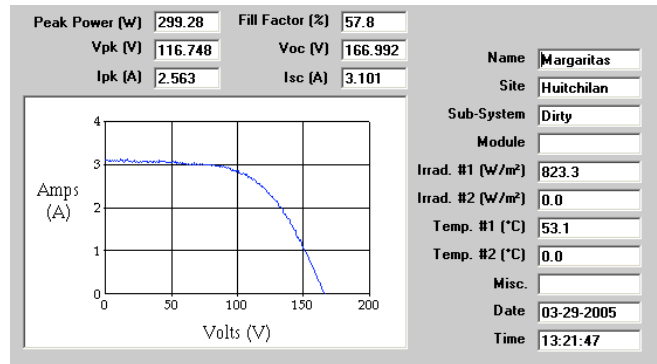
Fig. 3. Huitchila PV Array in Las Margaritas.

Both arrays are mounted on metal painted fixed posts, with the array tilted 20 degrees for Las Margaritas and 22 degrees for El Amate. These are acceptable array tilt angles for Morelos (Lat ~18°N). In Las Margaritas the array is installed with an orientation of 178° magnetic South and the array at El Amate is oriented to 180° magnetic South (the local magnetic declination is about 6° W). In both arrays, the six First Solar PV modules are wired for 2 modules in series and 3 in parallel (2S x 3P). The arrays are wired for a nominal 122 Vdc operation. The Margaritas system was pumping water at the rate of 40 lpm at 840 W/m<sup>2</sup> irradiance with 13.76 m total dynamic head, while El Amate was pumping 41.5 lpm at 650 W/m<sup>2</sup> at 12.2 m total dynamic head.

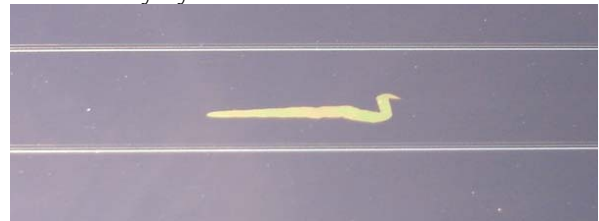
Visual inspection of the arrays found no module delamination or other evident problems. A small manufacturing anomaly was found on one of the modules for Las Margaritas, but it did not affect module performance as noted from its I-V curve. The anomaly appears to be a film scratch caused by handling of the modules by First Solar personnel during the manufacturing process. First Solar claims that their latest product is now produced with newer manufacturing processes, which have virtually eliminated human handling of the product until it is finished and laminated, so these types of scratches are no longer an issue [2]. The scratch found did not affect the performance of the First Solar module.

Fig. 4. Inconsequential manufacturing film scratch present on one of the Margaritas First Solar PV modules.

A few of the First Solar modules showed some small manufacturing film scratch anomalies related to production. Small scratches, typically no more than a centimeter in length, were found in only a few cases. However, these had no apparent effect on module output and First Solar states that these types of manufacturing anomalies no longer occur.

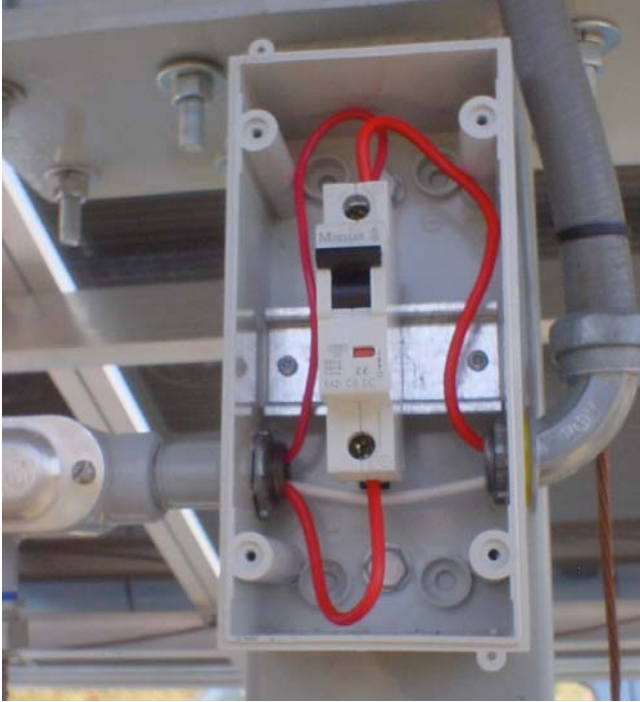
Both systems incorporate a Moeller FAZ C6 DC breaker rated at 220/250 V to disconnect the PV array. The disconnect device is located in a rainproof enclosure under the array as shown below. A Delta Lightning Arrestor is also used for lightning protection. Array wiring consists of THWN 12 AWG ConduLac wire in conduit. All module frames are bonded to ground using 8 AWG copper conductors, as well as the negative conductor. A 3 meter grounding rod was installed at the base of the array.

Fig. 5. Array disconnect using Moeller FAZ C6 DC

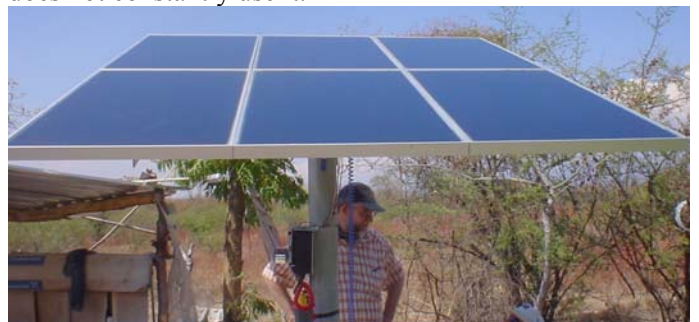
The installation showed inferior quality workmanship. The wiring connections were simply twisted and taped together. One module frame bond had loosened as was no longer attached to the frame. Current leakage was found during the wet Megger test since module interconnects are only taped and twisted, this allowed for water intrusion and subsequent current leakage. No delamination or hot spots were detected in any of the modules.

Fig. 6: El Laurel PV Array under test by NMSU and UNAM.

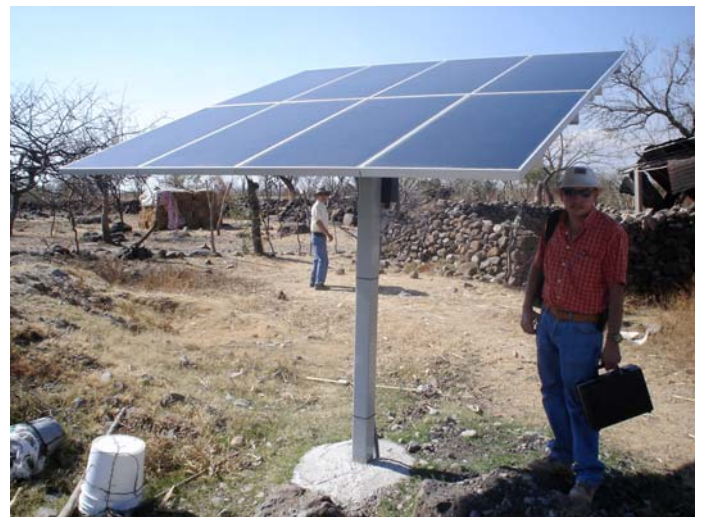
The El Corralito PV water pumping system serves a small ranch and has a well that is 96 m deep with a water level of about 23 meters. The array is mounted on a painted metal post and tilted at 23 degrees, which is an acceptable inclination for Morelos (Lat ~18°N). The array is installed with an orientation of 164° magnetic (the local magnetic declination is about 6° W). The 8 First Solar modules are wired 2 in series and 4 in parallel (2S x 4P). The arrays are wired for nominal 122 Vdc operation. Despite the hour growing late, system tests were conducted after 4:00 p.m. when the irradiance was low and the sun incidence angles high (i.e., far from perpendicular). Given the late hour and the low irradiance level the uncleaned modules were tested at, the overall system test was inconclusive and no water pump test was conducted. Overall summary test results for all four Morelos PV systems including El Corralito are provided in Table 2.

Fig. 9. El Corralito PV system array.
